Job Name: Vinton Building  
Job Location: Detroit, MI

### **HISTORIC WINDOW SITE REVIEW:**

## Vinton Building—Typical Window Photographs

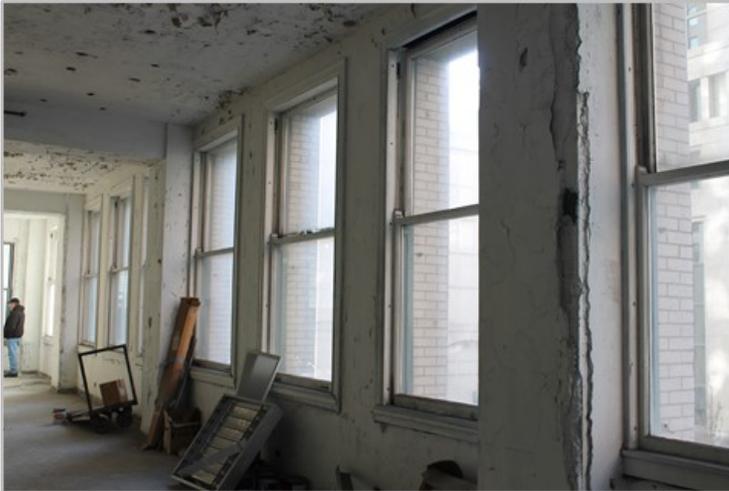
1. Double-Hung Wood Window

The existing wood windows are located on the primary facades of the West and South Elevations of this 12 story masonry building [Photo 1]. These windows are true double hung with both the upper and lower sash operation using a chain, weight, and pulley balance system [Photo 2]. One of the complexities of this project is a previous window restoration project that incorporated the retrofit of the existing monolithic ¼" annealed glazing to a ½" insulated glass unit. The work appears to have been done in the last 5 to 8 years, and was poorly executed. The existing wood sashes were altered by cutting a glazing pocket for the insulated units with a routing tool. The glazing units were set with silicone and stopped in from the exterior with a wood stop. The exterior stops are warping and failing; many of the insulated glass units are failing because of improper spacing, as well as being sized incorrectly allowing the edge banding to be exposed to ultraviolet exposure causing premature aging and breakdown.

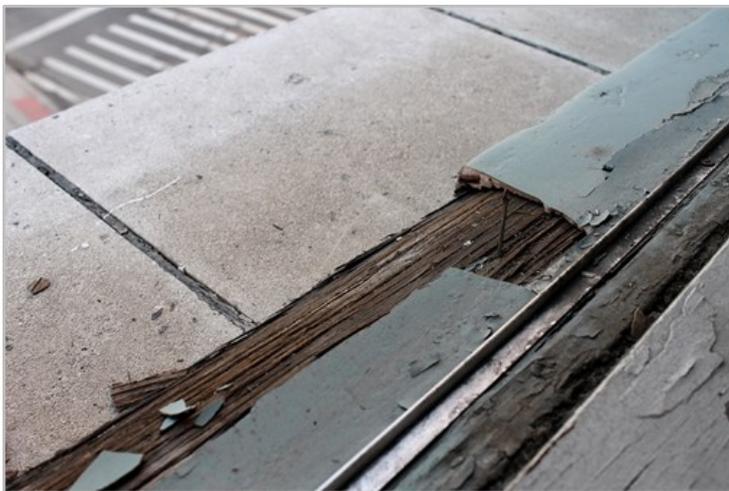
3. Wood Double-Hung Sill

Over 50% of the exterior sills are failed and splitting or show the presence of epoxy patching but this has cracked and failed also [Photo 3]. At least 35% of the frames have failed joinery at the jamb and sill intersection, and there is evidence of dry rot. The end result of this work is that all sashes would need to be replaced as well as the trim components. The frames likewise, are failing and would require replacement.

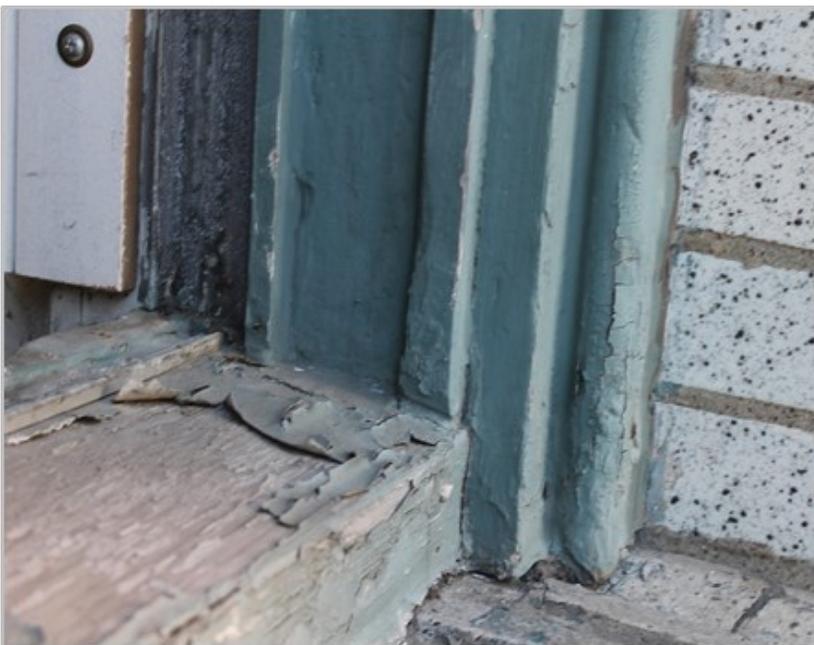
4. Wood Double-Hung—Sill, Jamb, Brick Mould, Parting Bead and Stop Bead,

The existing windows have a critical site line dimension from the masonry jamb to the glass edge of 4 1/2". The sash are 2 1/4" thick and fit in a 2 3/8" sash pocket. The blind stop is 7/8" x 1/2", the parting bead is 1/2" x 1/2". The sash top rail and side rail are 2 1/4", the bottom rail 3 3/4", and the meeting rail is 1 7/8". The exterior brick mould is 1 1/2" x 2 5/8". The interior and exterior finishes are painted but in fair condition [Photo 4]. I would suggest that the material is tested for the presence of Lead and Asbestos.
