Job Name: Gibson Building
Job Location: Kalamazoo, MI

HISTORIC WINDOW SITE REVIEW:

The following is the written Historic Window Site Review for the windows on the first, second, and third floors for The Gibson Building at 225 Parsons Street, as well as the windows in the adjacent Executive Suites Office building. This information is based on a physical site visit, and inspection of the existing windows. Our review considers the National Park Service guidelines for restoration and replication as provided in the NPS Steel Window Repair and Preservation Brief #13. Likewise, in providing our recommendations for the restoration or replacement, we are adhering to the guidelines that meet NPS and SHPO standards. Please note this review is our opinion based on over 30 years of historic window restoration and replication experience; however, you must have written approval from NPS, SHPO, and the local Historic District Commission to be assured of the projects' tax credit approval (if applicable) or historic district compliance.

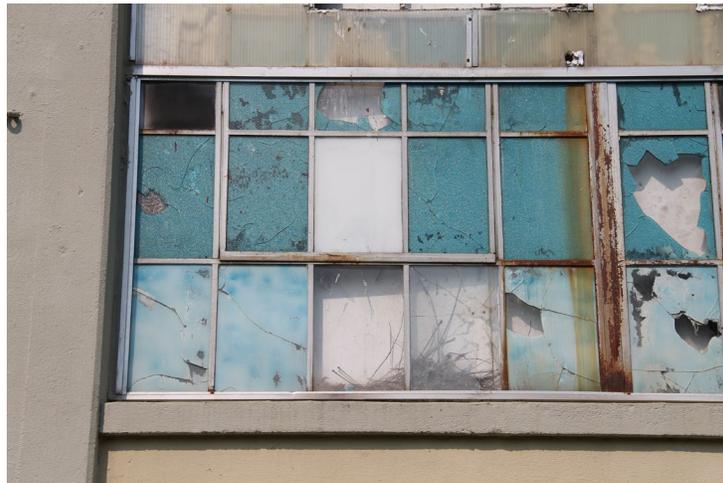
STEEL FIXED PROJECTED WINDOW

The following are typical site line dimensions for the Industrial Steel factory style windows include a $1\frac{3}{4}$ " bottom frame and rail, $1\frac{3}{4}$ " jamb and stile rail, $2\frac{7}{8}$ " top head and sash rail, $\frac{7}{8}$ " muntin, site line, and 6" vertical mullion (glass to glass). Many of the frame rail dimensions vary depending on the location and how they were originally installed. Some were buried in the surrounding masonry at different depths. The overall frame depth or thickness is $1\frac{3}{4}$ ". All the existing glass is $\frac{1}{4}$ " float, many areas the glass has been replaced over the years or is broken. The perimeter caulking and putty glazing is most likely containing asbestos as was previously mentioned. A hazardous materials inspection and report needs to identify what if any concerns exist. The overall condition of these windows is poor and have failed.

Recommendation: Complete Removal and Replication of all existing windows.

BlackBerry recommends the full replacement of the existing steel windows based on the overall poor condition of the components and the fact that approximately 85% of the windows currently do not operate and/or have key components such as sills and sash components that are in varied states of failure. There are currently replica

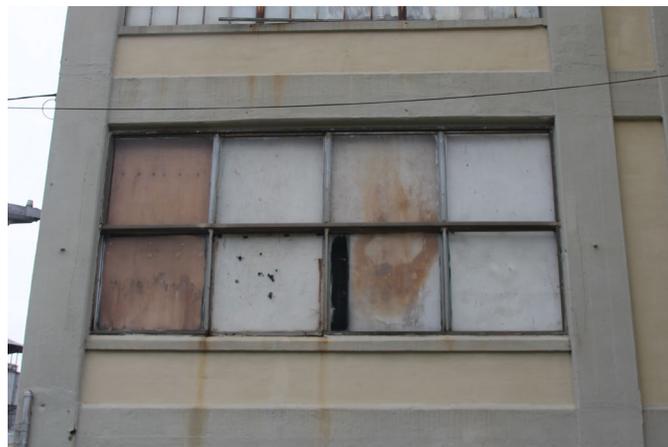
STEEL DOUBLE HUNG EXTERIOR

The following are typical site line dimensions for the steel hung windows which include a 3" bottom rail, 2" side jamb, $2\frac{7}{8}$ " head on the exterior side, and $1\frac{3}{4}$ " meeting rail, and $4\frac{1}{2}$ " vertical mullion. All the existing glass is $\frac{1}{4}$ " float. The same condition exists regarding the ACM. The overall condition of these windows is poor and have failed. Details have been attached showing existing profiles and dimensions.

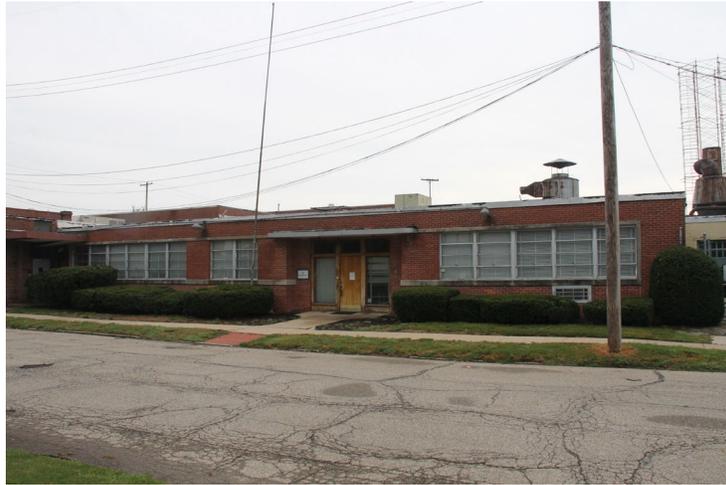
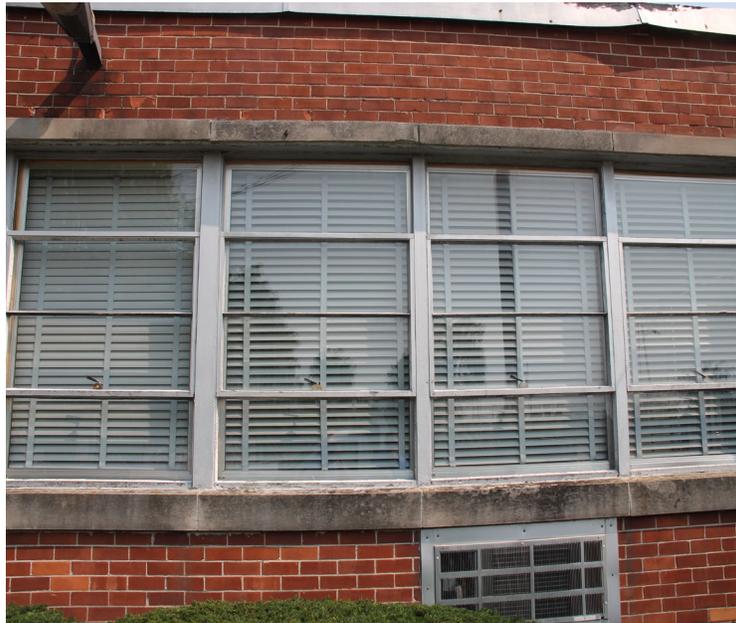
Fixed Projected Window

The steel fixed and projected windows are original to the building that appears to have been constructed in the 1950's, The fixed and panel openings had the original steel glazing portions replaced with an aluminum frame and insulated glass probably in the 1980's by the look of the material used. The steel fixed and projected windows are outside putty glazed with a glazing compound and perimeter caulking that most likely has ACM. The glazing is 1/4" clear annealed in fair to good condition, the windows are painted both inside and out, and show minor surface rust coming through. The windows could be restored, but since they are steel and have no thermal break, I would assume the Owners preference is to replace them with an energy efficient thermally broken aluminum replica product.

Recommendation: Removal and Replication of all existing windows.

Products exist that can replicate both these window types to meet the NPS/SHPO guidelines. We will move forward to review manufactures and product options to propose with details and dimensions. These products would be thermally broken aluminum windows.

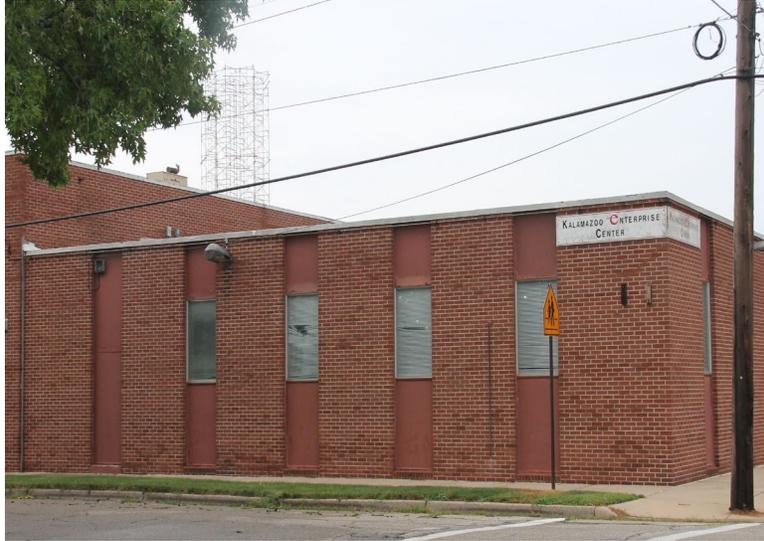
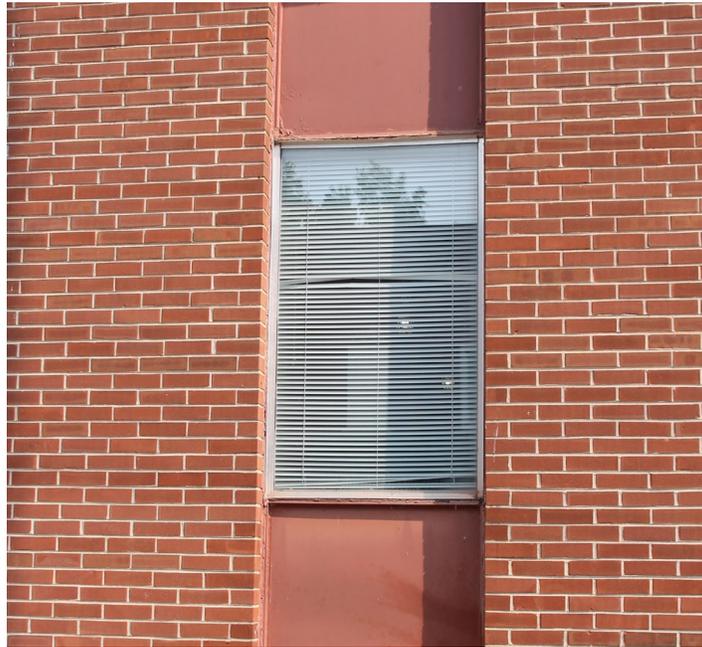
Fixed Panel Window

The Fixed Glass and Panel product is in similar condition, however, there is greater evidence of rust on the original fixed panel frames that have been caulked and painted multiple times to cover the corrosion. The openings are in poor to fair condition. Our recommendation would be to replace these units. Details have been attached showing existing profiles and dimensions.
