Job Name: 28 N. Saginaw  
Job Location: Pontiac, MI

## **Historic Window Site Review: Preliminary**

## 28 N. Saginaw—Typical Window Photographs

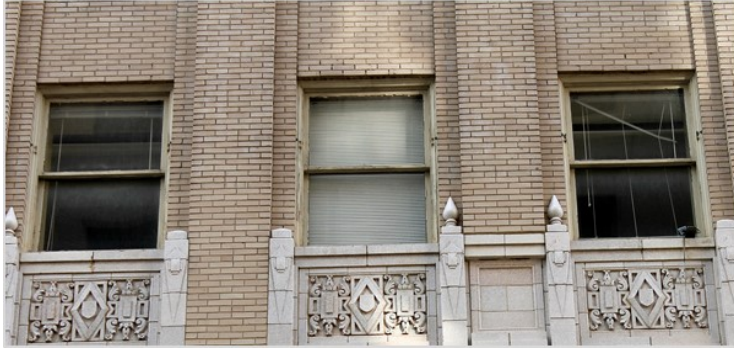
1. Wood Double-Hung Windows

The wood windows are located on the North and West Elevations of the 14 story building as well as the Penthouse level [Photo 1]. These windows are a traditional wood double hung, chain and pulley operation. These windows are original to the building dating back to its initial construction in 1928. There are locations where over the years some selective replacement has taken place with an aluminum double hung window or fixed over awning units. All the windows appear to be white pine; this includes the frames, sashes, sill, and brick mould. All the sashes are one lite without any muntins. All sash are exterior putty glazed and are 1 ¾" thick, all side rails and top rails are 2" from glass to exposed sash edge, the bottom rail is 3 ½", and the meeting rail is 1 ¾". ¾". The exterior brick mould sits on the exterior wood sill and is 2 ¼" x 2", with adjacent perimeter caulk bead to the exterior masonry. The exterior sill face is 1 ¾" and the dimension from the stool edge to the sill edge is 7 ¼". All glass appears to be ¼" clear annealed. The remaining exposed wood components include ½" x ½" parting bead, ½" x 1 ⅜" sash trim, and 7/8" x ½" blind stop. The exterior surfaces of all wood windows are painted and are in fair condition, lead paint is assumed to be present [Photo 2]. The perimeter caulking is failing and should be tested for asbestos, which is usually present in a building of this age. The exterior putty glazing is in fair condition and failing, it should also be tested for asbestos [Photo 3].

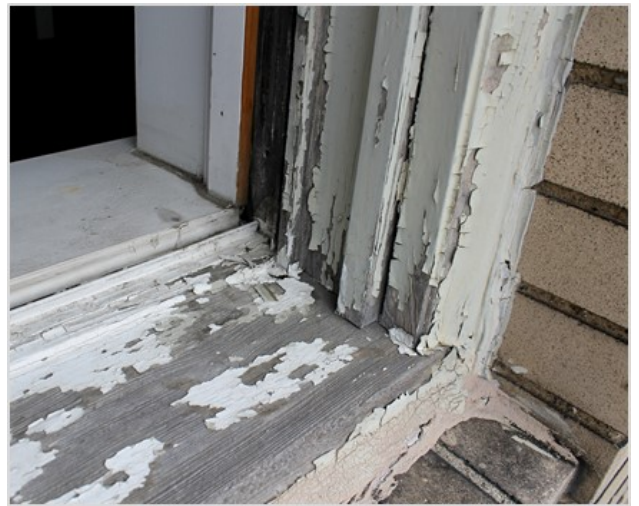
4. Wood Double Hung Sill and Outside Casing,

From the windows we had access to view; the following information is what we can provide as an overview. The upper sashes are painted shut, and the lower sashes are fastened shut or painted shut; their are some that operate but they do not function smoothly. They appear to have most of the hardware in place including the pulleys, chain, weights, and lock and keeper. The majority of the window glass is slightly hazed and weathered beyond just needing to be cleaned, this glass etching takes place over time. The existing windows had a metal fin weather stripping that is worn, broken, or missing in most cases. The exterior sills we could view were well intact with little open grain or decay. Some of the bottom sashes were very weathered, some with failed bottom rail corner joinery and decay [Photo 4].

BlackBerry would recommend the full restoration of the existing frames, sashes, sills and brickmould; as well as retrofitting the existing sash, allowing for high performance energy efficient insulated glass. New sash stop and parting bead would be created since these items are in poor condition. New hardware would be included, but we would recommend fixing the upper sash in place to improve the thermal performance by lowering air infiltration. Those lower units that are to operate would require additional sash weights to accommodate the heavier insulated glass units. New weather-stripping should be added to upgrade the overall thermal performance. If not, all units are required to open, we would suggest fixing both the lower and upper sash which would save on material and restoration cost by about 7 to 10%. We would note that upon a full evaluation of the existing windows we might find that a full replication of the sash would be the best option since this could be more cost efficient than restoring the existing sashes, and we can eliminate the exterior putty glazing and provide a more durable long term product.

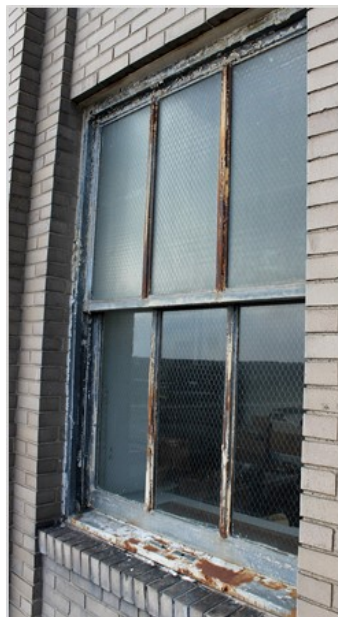
5. Cold Rolled Steel Double-Hung Window

The steel windows are located on the South and East Elevations of the 14 story building as well as the Penthouse level. These windows are Voigtmann cold rolled steel double hung windows. They are original to the building dating back to its initial construction in 1928. There are locations where over the years some selective replacement has taken place and new aluminum fixed over projected awning windows has been installed. The typical configuration is both the upper and lower sash having two vertical muntins measuring 2" in width [Photo 5]. The operation is a chain and pulley balance system with steel weights very similar to a traditional wood double hung window. The steel frame and sash is galvanized sheet metal roll formed to create the resulting shape. These windows are fire rated and include 1/4" wire glass, which was common for the era of the structure [Photo 6]. The galvanizing has failed and corroded on about 50% of the exterior surface area [Photo 7]. For the most part there is no remaining paint on the exterior surface, so surface corrosion is visible on all sash, frames and sills. The exterior perimeter caulking has failed and should be tested for asbestos [Photo 8]. The interior surfaces are all painted and should be expected to be lead paint. The exterior sill face is 1 1/2", the frame jamb face 1 1/2", the frame jamb head 2". The sash bottom rail dimension is 3 1/4", the meeting rail 2", and the side rail 1 3/4". In comparing the sitelines to a wood double hung they are similar and as a result from a street view, look the same or very similar to the wood double hung windows on the building.

From the windows we had access to view; the following information is what we can provide as an overview. The upper sashes are painted or rusted shut, and the lower sashes are fastened or rusted shut in most cases. Those windows that do open do so with great effort because of the corrosion of the metal components including the sash edges, chain, and sash pockets.

Because of the condition of the existing steel windows being poor to fair and the problems with long-term corrosion and operation we have to recommend full replacement. The two possible pathways to follow are a wood replica product that matches the existing wood windows on the North and West Elevations, or a new thermally broken aluminum window. We have seen both products used on NPS Tax Credit projects. This would involve direct discussion with SHPO and NPS to determine the appropriate pathway. A third option may involve replacement of all windows both wood and steel with an approved thermally broken aluminum window. This could be considered if a full survey shows the condition of both types of windows on the building to be in need of replacement.

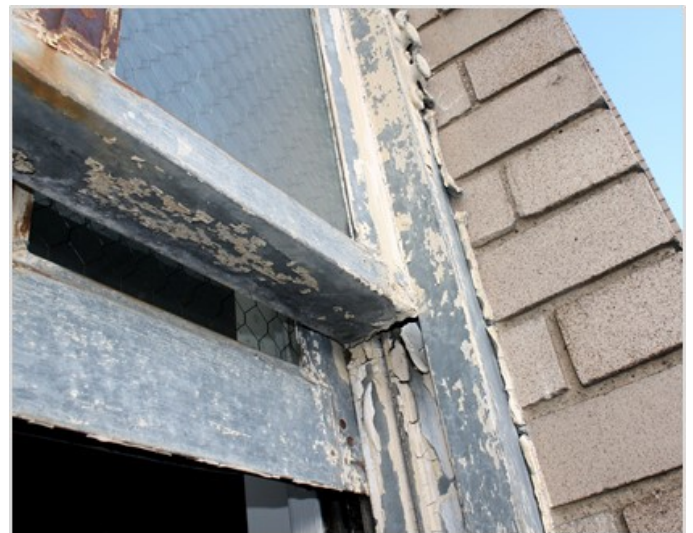
6. Steel Double Hung Upper sash meeting rail and lower sash bottom rail

One of the key factors is that all the glass would need to be replaced since all the glazing compound is dried out and brittle as well as the assumption that wire glass would not be acceptable for the future end user. We did not observe any corrosion to the point of the metal failing or requiring epoxy patching. Some sash and frames were dented and bent restricting some windows from operating fully or smoothly.
